The Colorado Floods

The Storms of June 14-20, 1965

NWS Denver/Boulder

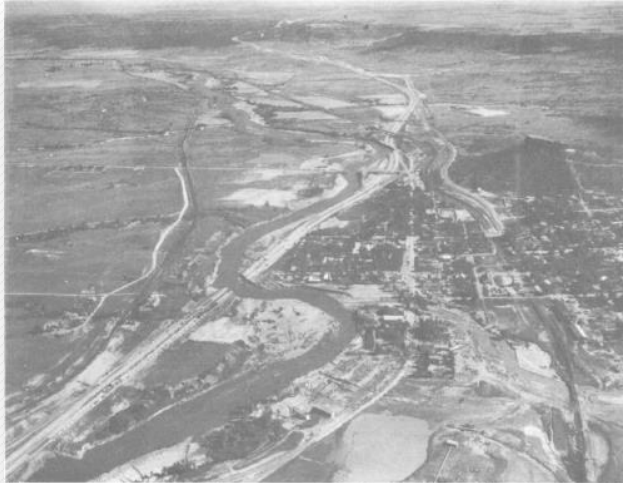
#1 Destruction of highways and bridges due to flooding and bank erosion at Castle Rock on East Plum Creek.

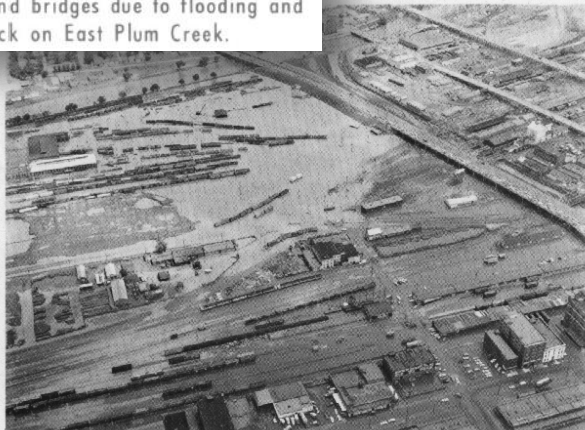
(19) From high above the lower downtown area, the confluence of Cherry Creek and the South Platte River is seen at the top of the photo. The eastern edge of the inundated area runs through the buildings at the bottom of the picture. The 14th, 15th and 16th Street Viaducts run across the upper right of the photo.

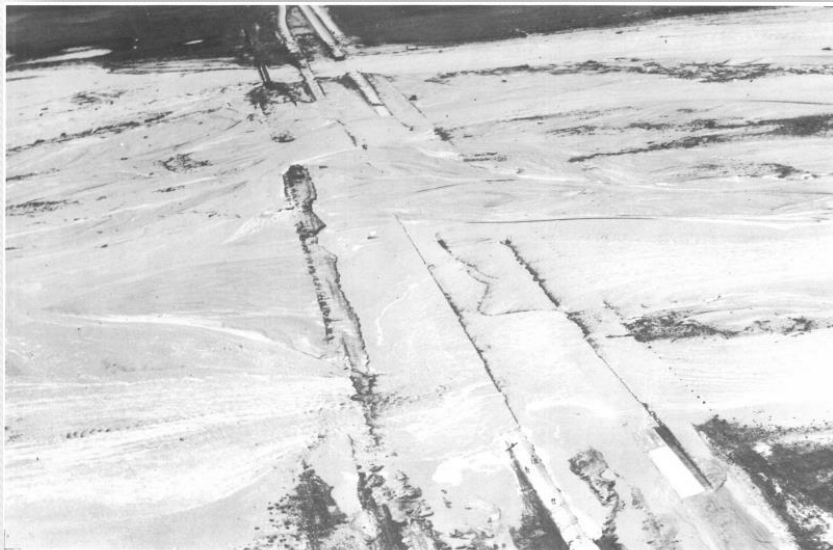
#25 Bijou Creek east of Wiggins, Colorado. Note heavy siltation and erosion of highway and railroad grades.

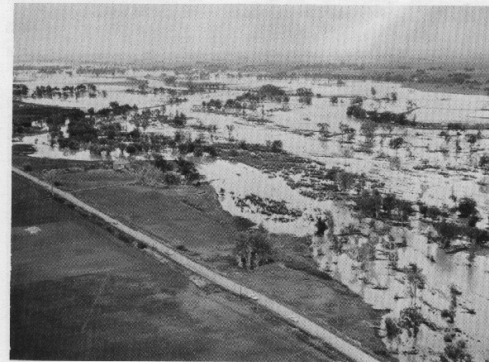
(1) The massive flood on the South Platte River spreads out over a wide expanse of land just east of Thornton.

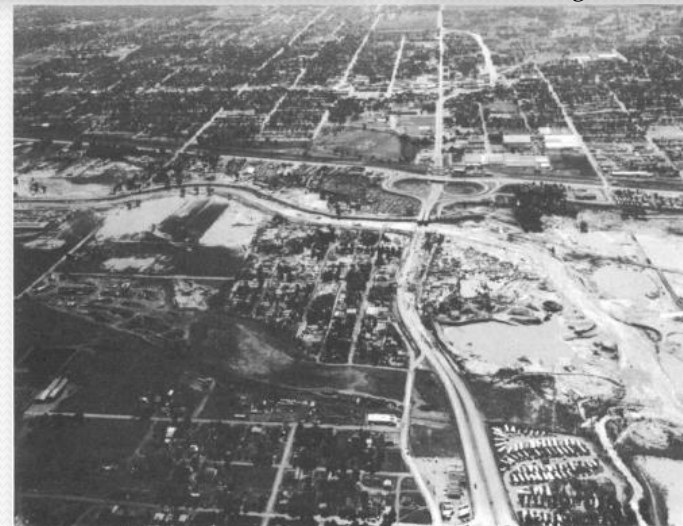
#17 Aerial view showing receding flood waters of the South Platte River at the south edge of Denver.

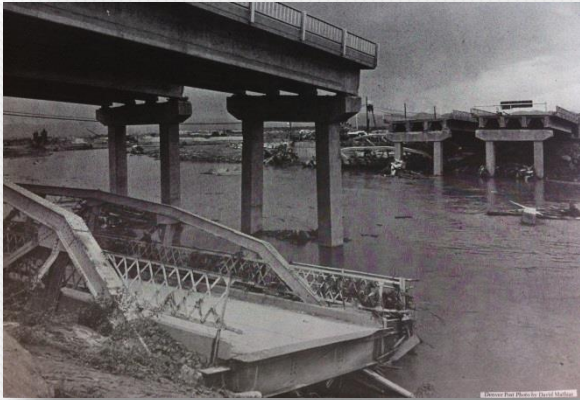
- Nearly all east/west bridges through Denver were destroyed by floodwaters.

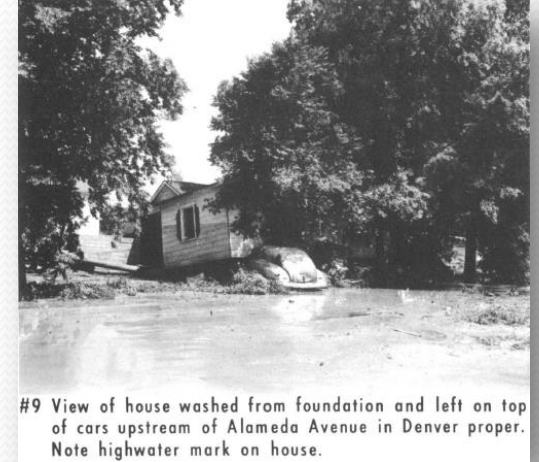
#9 View of house washed from foundation and left on top of cars upstream of Alameda Avenue in Denver proper. Note highwater mark on house.

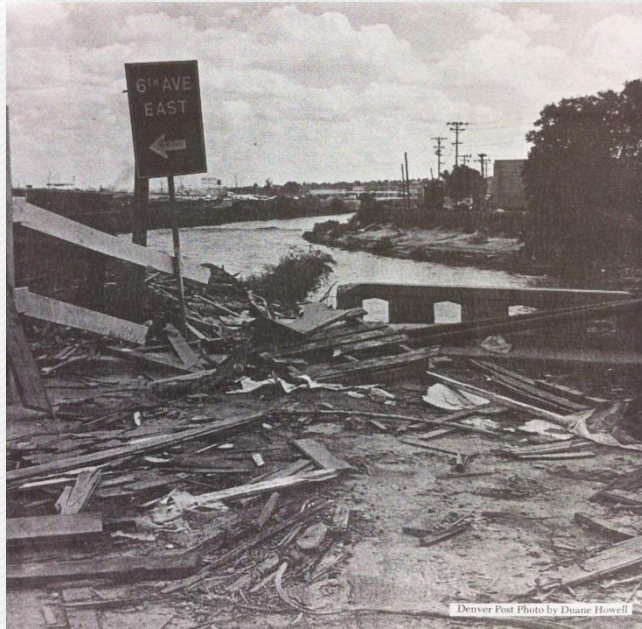
- Bridges were destroyed not because of poor quality, but because of pressure built up from debris.

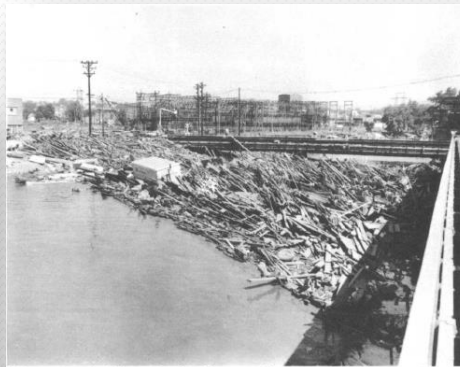
#11 View of debris lodged at 13th Avenue bridge in Denver proper. Truck can be seen in center photograph.

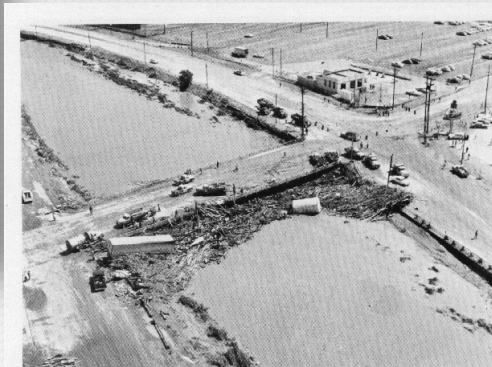
(37) In this view of the West Mississippi Ave. bridge we are looking downstream and see a large truck trailer and some tanks caught in the debris lodged against the structure.

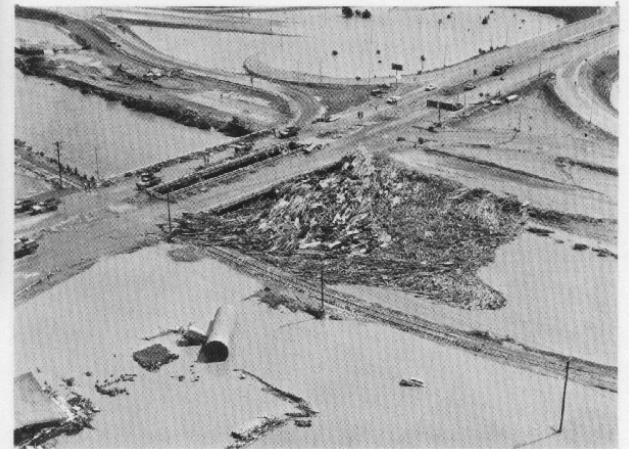
(28) The greatest single concentration of flood debris within Denver, containing cars, truck trailers, house trailers, campers, tanks and hundreds of thousands of board feet of new and used lumber is lodged against the West 6th Ave. bridge. Note the car crushed by the huge pipe in the foreground.

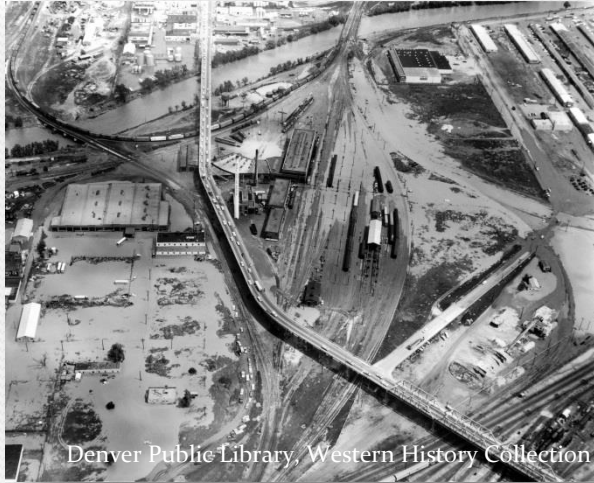
X-29251

- The rail yard in south Denver was completely flooded.
- 67% of flooding in Denver occurred in the industrial area.

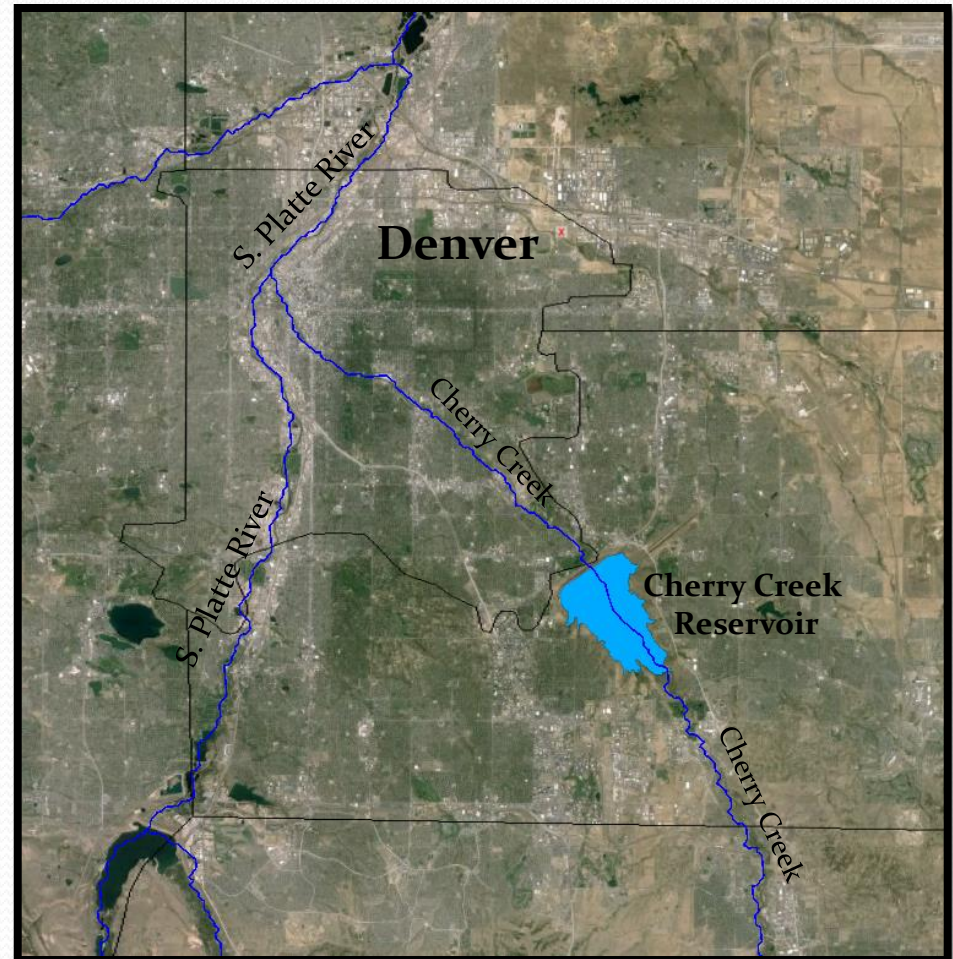
Cherry Creek Reservoir

- All of the excess flow from Cherry Creek was stored in the Cherry Creek Reservoir.
- The building of this dam was controversial, but proved its worth during this flood.
- Damage in Denver would have been astronomically greater without it.

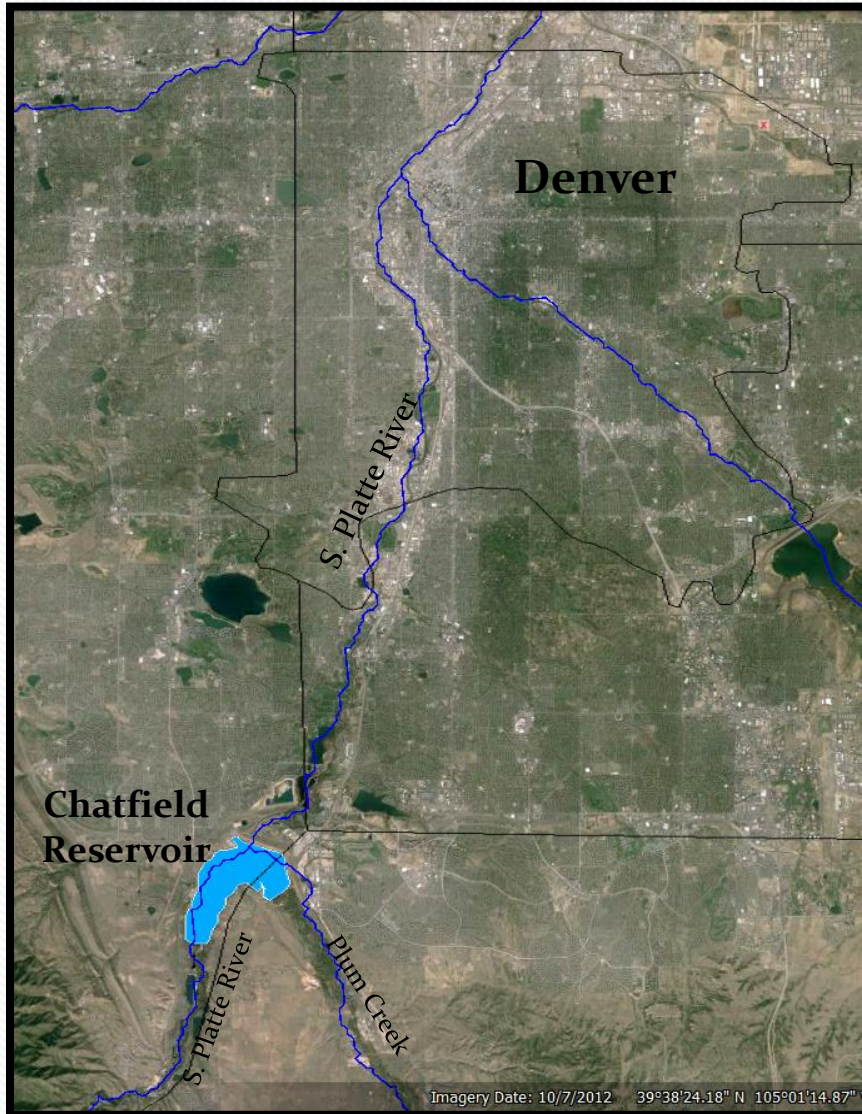
Chatfield Dam & Reservoir

- Construction began in 1967, as a direct result of the 1965 flood.
- The dam and reservoir were completed in 1975.
- Located south of Littleton, the inflow comes from Plum Creek and the South Platte River.
